Technical Report REMR-CS-63
September 1999

Repair, Evaluation, Maintenance, and Rehabilitation Research Program

Repair and Rehabilitation of Dams: Case Studies

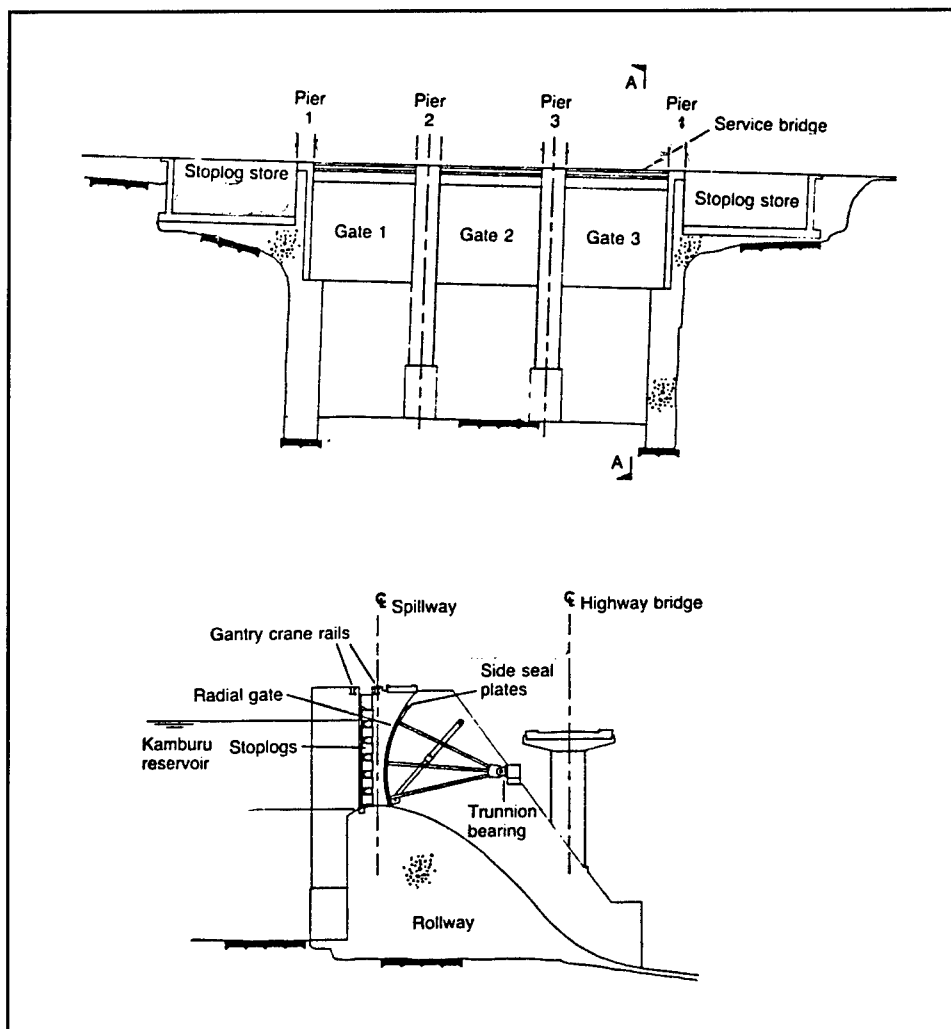
In 1982, eight years after the construction of the spillway, relative movement was observed between Pier 1 and the adjacent stoplog store. This movement was monitored for 3 years until, in 1985, it was found that Pier 1 had deformed into the gate opening to such an extent that gate operation was impossible. An investigation at that time revealed cracks in the concrete on Pier 1 and water seepage through horizontal cracks 20-30 mm wide that were parallel to and adjacent to the tendons securing the gate trunnion. The cracking pattern within

Figure 130. Upstream elevation and typical section of Kamburu Dam Spillway (from Sims and Evans 1988)

the left stoplog store confirmed the that the store was tilting. A study attributed the cracking to drying shrinkage, plastic shrinkage, plastic settlement, and alkali-silica reaction (ASR). This case history is a summary of a report by Sims and Evans (1988).

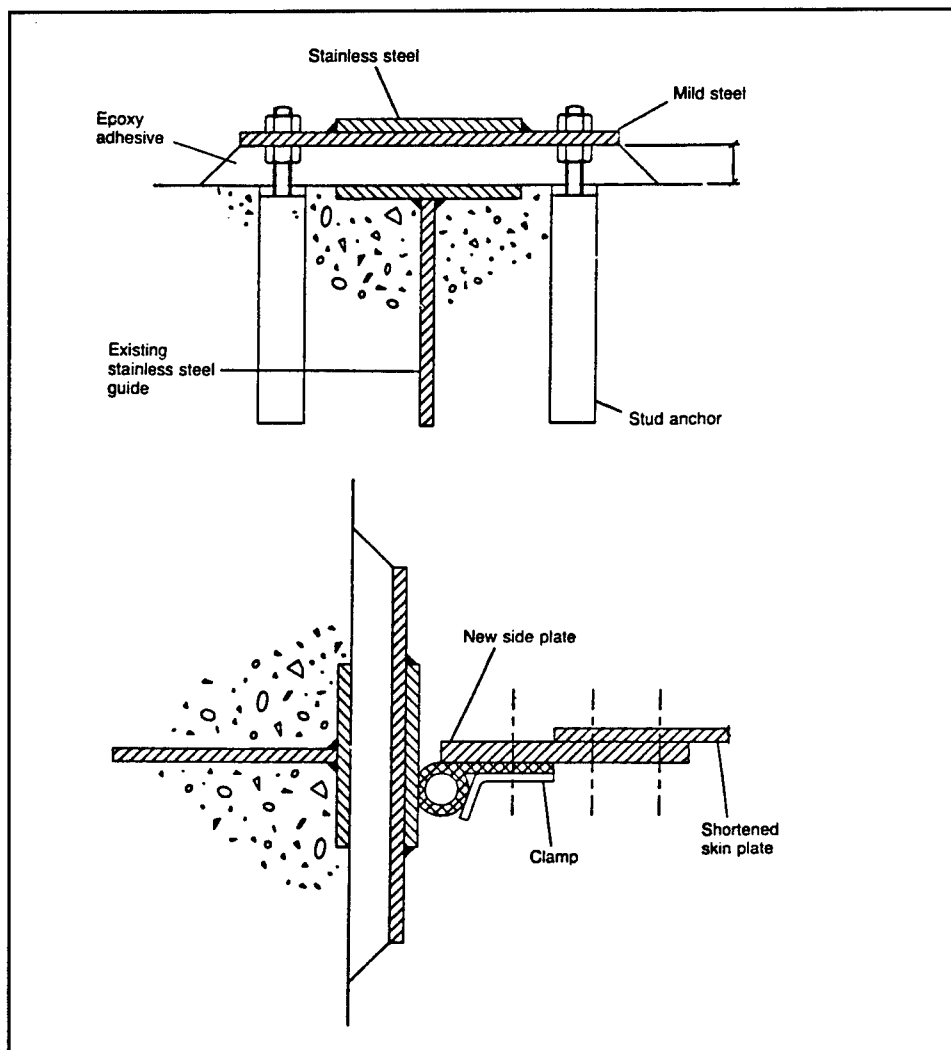
Figure 131. Modifications to radial gate, embedded parts and skin plate, at Kamburu Dam Spillway (from Sims and Evans 1988)

Gate 1 was released by trimming 140 mm (5.5 in.) off the side of the gate adjacent to Pier 1. Figure 131 shows the revised arrangement for the seal and also the new stainless steel sealing face. After the gate was released, the alignment of the gate arms and trunnion bearings were checked, and minor adjustments had to be made to relieve stresses induced by the misalignment of the gate and piers.

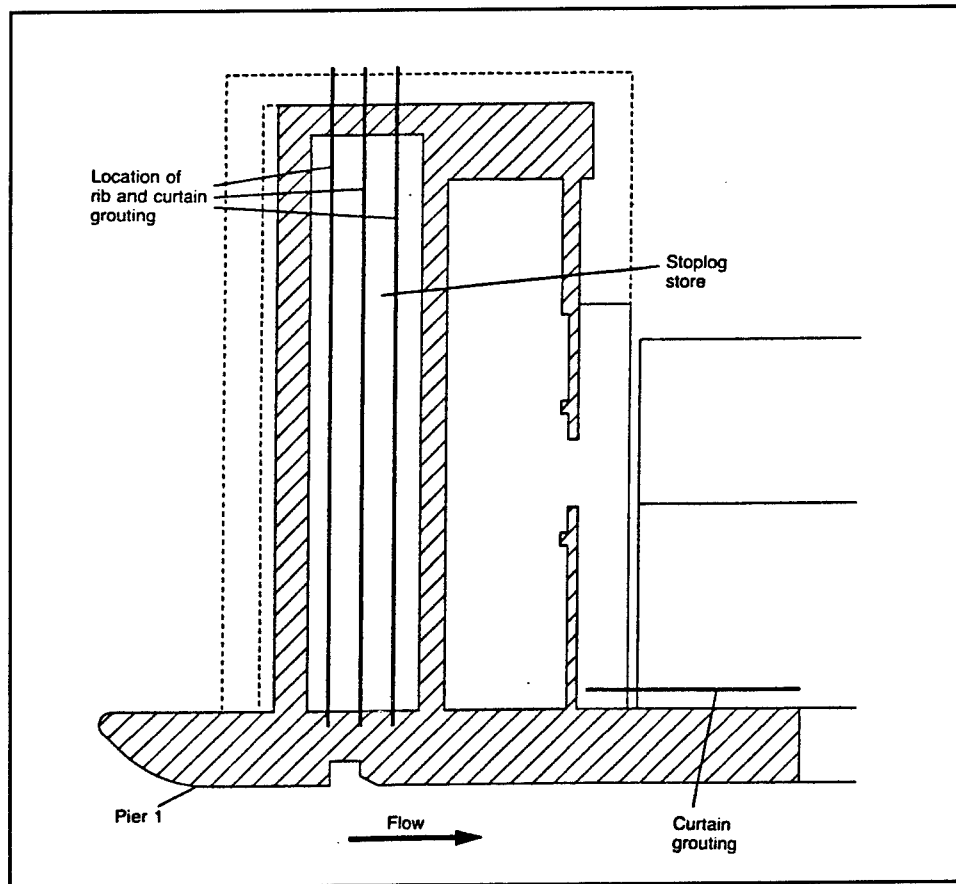
Figure 132. Grout locations on Pier 1 of the spillway at Kamburu Dam (from Sims and Evans 1988)

The measure taken to reduce the water available to the concrete included the following. The existing grout curtain under the stoplog stores was reinforced by placement of both a low-alkali cement grout and resorcinol-formaldehyde resin grout (Figure 132). Immediately under the stoplog store, a combination of curtain grouting and rib grouting was used, the curtain grouting being straight down to the spillway foundation level and the rib grouting inclined at about 1 radian (60 deg) to the vertical to intersect with the rear face of the pier. Both the curtain and rib grouting were carried out in three rows. The two outer rows were grouted first with cement grout. The central row was grouted later, first with cement and subsequently with chemical grout. This grouting reduced the overall permeability of the abutment rock. Additional protection to Piers 1 and 4 was provided by a further curtain of cement grout followed by chemical grout between each pier and the abutment rock.

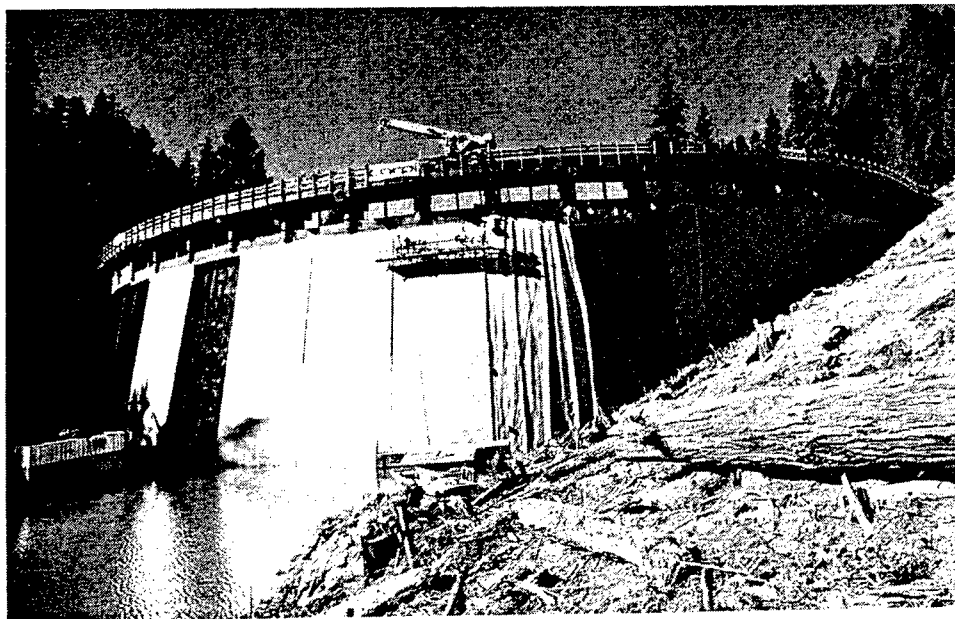
Figure 136. Workers on swing stages install 16 precut geomembrane panels on the upstream face of Lost Creek Dam (from Onken 1998)

To install internal profiles underwater, divers worked from swing platforms that were controlled from a materials barge. They used grid lines as guides to ensure the internal profiles were installed in a perfect vertical line. Gasket material was placed on the installed vertical profiles to provide a watertight seal at the membrane joints. The geomembrane was installed next. Using a crane, workers lifted the top end of each of the 16 panels until it was level with the upper perimeter seal, pulled it to the dam face, and then unrolled the remainder of the panel onto the materials barge and into the water. Divers aligned the panels with the installed internal vertical profiles, making sure the panels overlapped sufficiently (Figure 136). The installation team on the bridge deck used chain falls and winches to make adjustments according to instructions from the divers. Once the panels were aligned, divers secured them to the dam face above the perimeter seal. Another layer of gasket material was placed over the geomembrane, and the external vertical profiles were clamped to the internal vertical profiles, creating tension between the two profiles and pulling the panels toward the face of the dam.

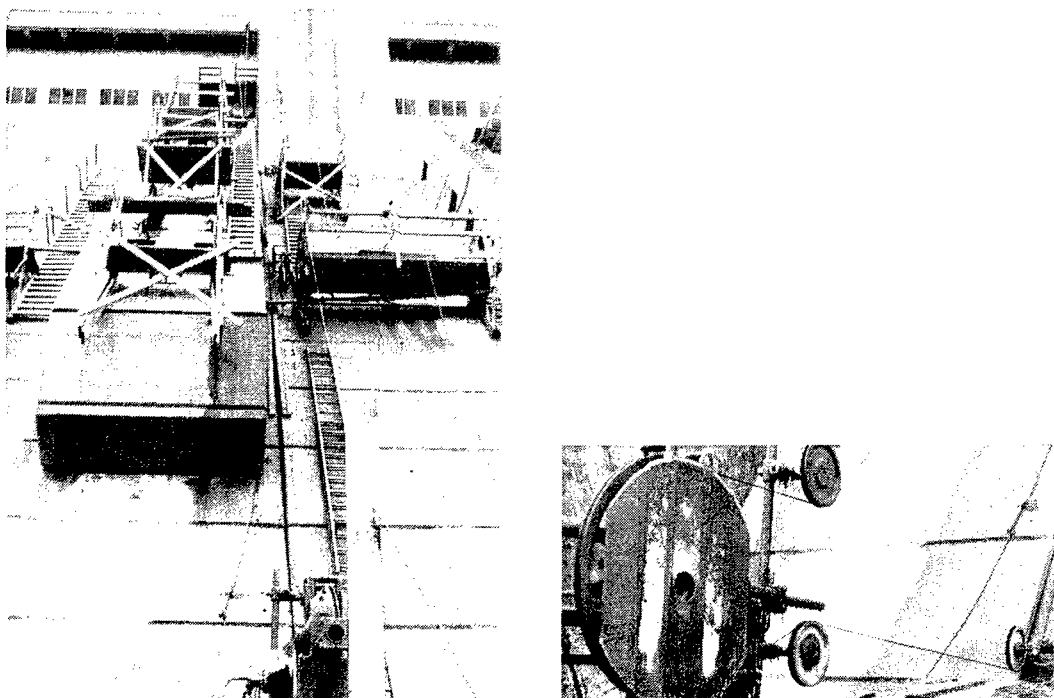
From the time the dam was constructed in the late 1960s, it had been slowly but steadily expanding. As a result, by 1988, a spillway structure pier had moved 30 mm (1-1/4 in.) off-line, there had been some gate obstruction and some cracking in the powerhouse generator floor. The expansion of the concrete

Figure 138. Diamond wire cutting of Mactaquac Dam

As the first cut closed behind the wire saw, the 'load' or pressure caused by the growth was transferred to the top half of the dam. Trentec's crew then moved their equipment to the very top of the dam (Figure 138) to begin the second vertical cut. The 10-mm- (3/8-in.-)wide cut began to close when the diamond wire saw was about 6 m (20 ft) from the top. The second vertical cut intersected the slot of the first cut, completing the project. The second cut relieved pressure on the top half of the dam.

Crews worked around-the-clock for 13 full days to make the two cuts, which covered a 483-sq m- (578-sq yd) cross-sectional area of the concrete structure. The 10-mm (0.4-in.) cut closed almost completely, and any small gaps were grouted and sealed. The leaning spillway pier “rebounded” by about 6 mm (1/4 in.) as the dam moved in and about (5/32 in.) 4 mm on the other side of the cut. The cutting program had “shrunk” the growing dam section about 10 mm (0.4 in.), the exact width of the cuts. This amount was estimated to be the equivalent of 1 year’s growth at the spillway east end pier.

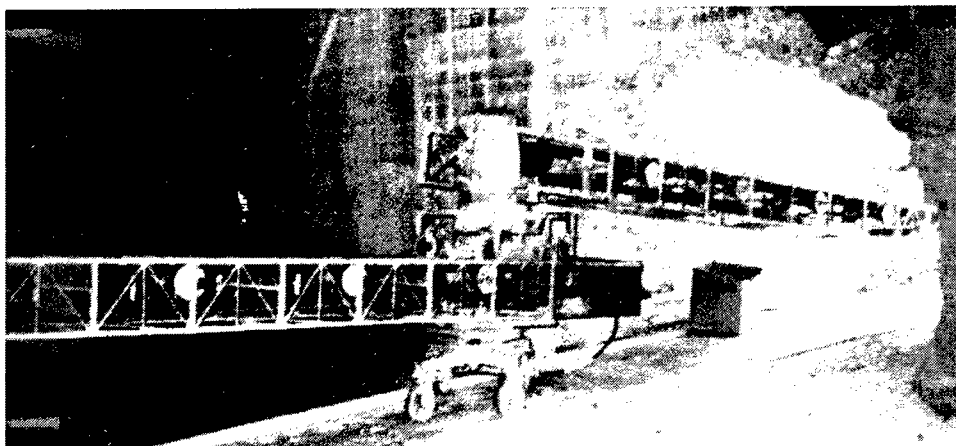
Figure 140. Muck being removed from bay at Morris Sheppard (from *ENR* 1988)

Construction and investigation. The construction and geotechnical investigations proceeded concurrently. A footing level, 2.4-m- (8-ft-) diam, passageway was drilled through buttresses into the enclosed spillway bays. Once the passageway had been constructed, each bay was mucked out and filled with crushed gravel to form a working platform for relief well and instrumentation installation (Figure 140). As the working platform was constructed, additional instrumentation and piezometers were installed farther upstream in the spillway bays. In total, 132 piezometers, 10 inclinometers, and 18 extensometers were installed to monitor the piezometric pressure and movement of the dam (Thompson and Waters 1989).

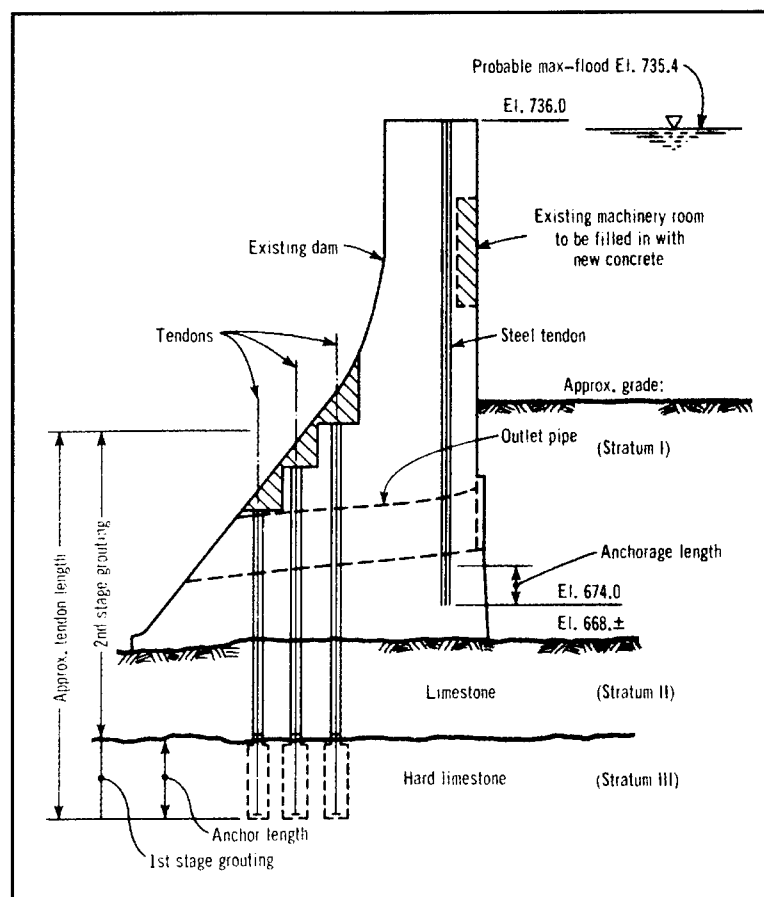
Figure 141. Placement of prestressed reinforcing to strengthen nonoverflow sections at Olmos Dam (from *Civil Engineering* 1982)

The first alternative considered was the placement of mass concrete on the entire downstream face of the dam. This option was rejected because of costs and the modifications to the existing stilling basin and sluice-way discharge at Olmos Creek that it would have required. The alternative selected was to strengthen the two nonoverflow sections with prestressed anchors installed in 2- to 3-m- (7- to 10-ft-) thick, hard limestone 15 m (50 ft) below the base of the dam (Figure 141) and to increase the stability of the spillway with mass concrete (Figure 142).

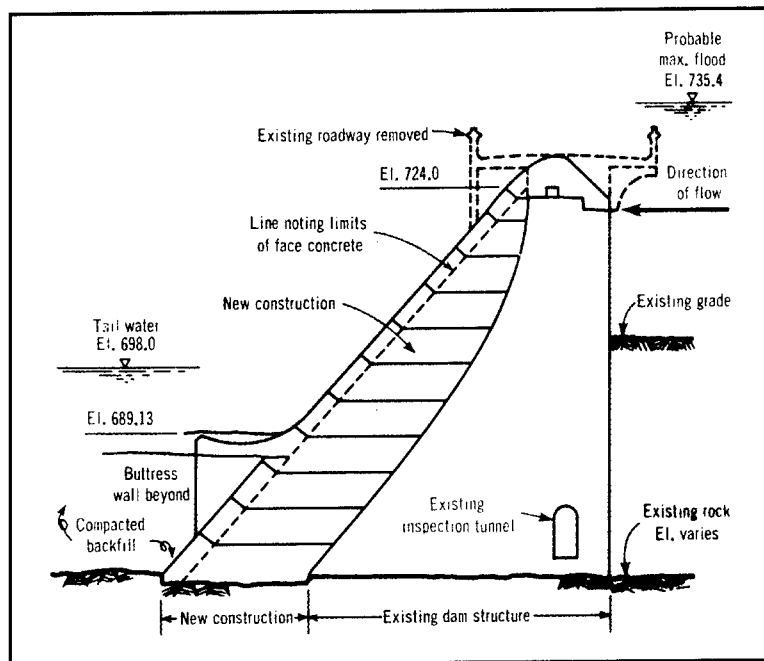
Figure 142. Spillway section strengthened with mass concrete at Olmos Dam (from *Civil Engineering* 1982)

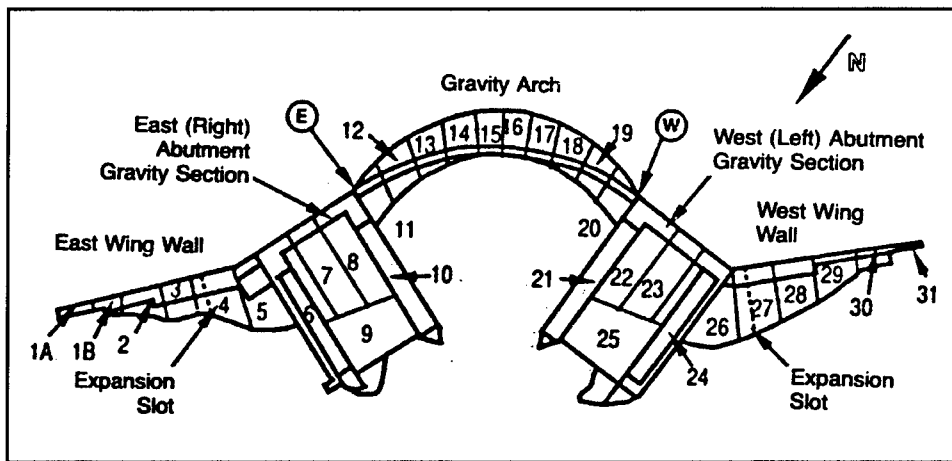
Figure 143. Layout of Shanteetlah Dam (from Bruce and Porcellinis 1991)

Routine measurement of deformation of the dam crest over a period of 25 years indicated that the crest had ratcheted (moved upstream in a cyclically increasing manner) since the 1930 and 1938 modifications, and the seepage volume had increased considerably. By 1987, seepage in the west abutment had reached over 4,000 lpm (1,050 gpm) and was entering the lower gallery at higher pressures and over larger areas than ever before. In addition, seepage from the downstream side of the gallery was also apparent (Bruce and De Porcellinis 1991).

Old construction records revealed that when repairs were made in 1930 and 1938 no structural connection was used to bond the new concrete to the old, except near the crest. Therefore, engineers attributed the steady ratcheting of the crest to thermal expansion caused by seasonal cycling. Displacements occurred along the interface between the original and new concrete. These upward deformations also caused construction joints to open seasonally, creating the possibility for concrete leaching (Bruce and De Porcellinis 1991).

A decision was made to use epoxy-resin grout to seal the joints and cracks in Santeetlah Dam. A 23-m- (75-ft-) long section in the most critical area was selected for treatment, which was conducted from within the lower gallery. The gallery is located about 3 m (10 ft) above the foundation and 4.5 m (15 ft) back from the upstream face. Cores up to 6 m (20 ft) long were taken from the upstream section of the dam to allow for inspection of the joints (Figure 144). The core holes revealed that water flows were traveling through the joints; the cores indicated the concrete was sound. A number of holes intercepted flows of 400 ℓ /pm (105 gpm) at full hydrostatic head (Bruce 1989).

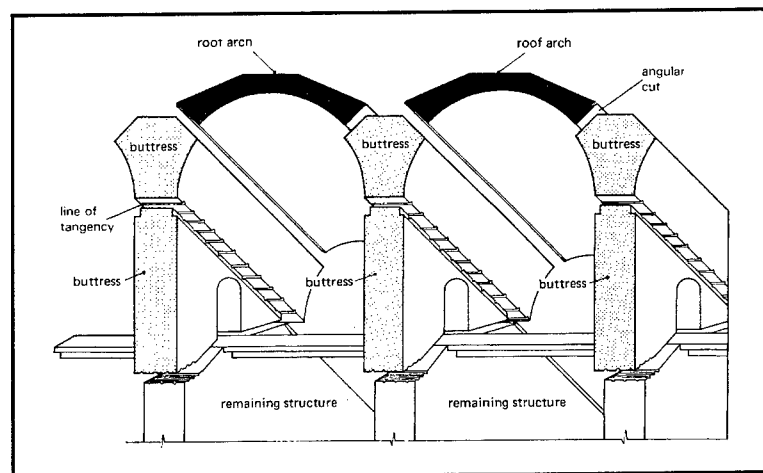
Figure 147. View of two arches prepared for removal at Sherman Island (from Beckman and Hulick 1991)

Work began on the upper arch sections. Two transverse cuts were made between the arches and buttresses in each bay across the 31-m (102-ft) width of the dam (Figure 147), and then three longitudinal cuts were made in steps along the 185-m (600-ft) length of the dam. The cut angle allowed the concrete arch to remain in position, without any additional shoring, until the contractor was ready to remove it. Access holes for the diamond wires, 20 to 40 mm (0.8 to 1.6 in.) in diameter and approximately 700 mm (28 in.) long, were drilled with percussion drills at the points where transverse cuts intersected longitudinal cuts. The wire saws were operated from the ground, from scissor lifts, or on large platforms anchored to the face of the dam. Some cuts required wires up to 80 m (260 ft) long (Beckman and Hulick 1991).

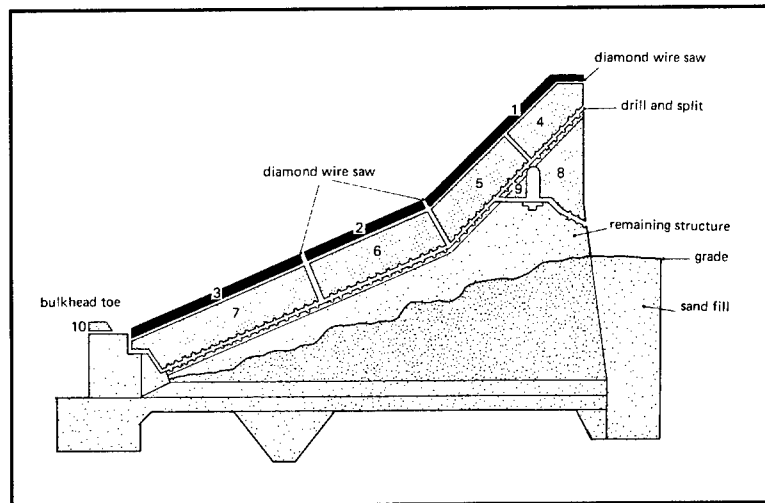
Figure 148. Order of removal of typical transverse section of Sherman Island Dam

Using the transverse and longitudinal cutting pattern allowed the contractor to remove sections in a checkerboard fashion. Buttress No. 4 was removed to grade to facilitate access through the dam. To prevent unwanted deflection of the remaining buttresses, temporary I-beam braces were bolted across each bay and then removed after arch sections on either side of a buttress had been lifted (Beckman and Hulick 1991).

Once the arches had been removed, the buttresses were drilled horizontally through the 1-m- (3-ft-) thick section along the line of tangency. Then hydraulic rock splitters separated the buttress along the unreinforced construction joint. Additional buttress sections were removed adjacent to the inspection gallery walkway, along with smaller sections at the bulkhead toe. Finally, bulkhead toe sections and other sections of concrete were removed from the lower upstream edge of the dam (Figure 148). The main scope of the concrete cutting work was completed within the required 16-week schedule (Beckman and Hulick 1991).

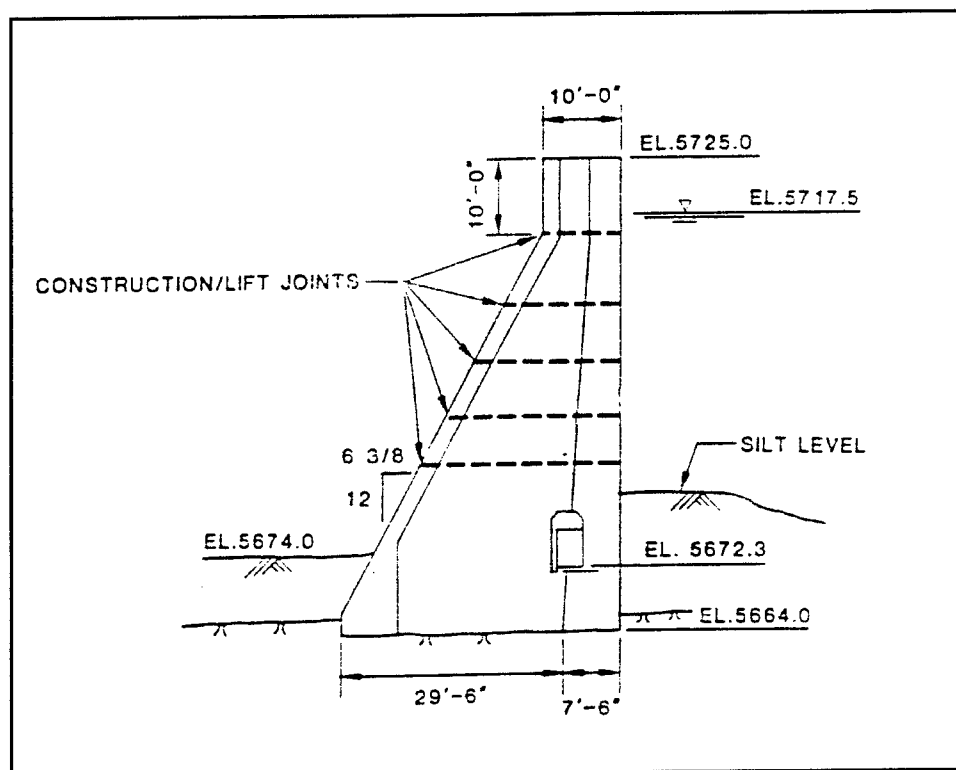
Minor leakage along lift joints has occurred during the life of the project. In the 1950s, a thin layer of shotcrete was placed on the downstream face of the dam in an effort to arrest concrete deterioration. Initially, this layer may have protected the surface from further deterioration, but ultimately, it probably contributed to increasing the rate of deterioration as minor leakage resulted in water being trapped behind the shotcrete. Inspections during 1990 revealed the existing shotcrete layer was delaminating from the underlying surface. This discovery prompted an investigation to determine the extent of deterioration. This case history is a summary of a report on the investigation and repair of Soda Dam by Marold, Koniarski, and Bruen (1992).

Figure 151. Nonoverflow gravity dam section at Soda Dam (from Marold, Koniarski, and Bruen 1992) (multiply feet by 0.3048 to obtain metres; inches by 25.4 to obtain millimetres)

reactivity; compressive strengths in the downstream face and upper 3 m (10 ft) of the structure ranged from 10 to 20.7 MPa (1,500 to 3,000 psi), while concrete in the body of the structure had compressive strengths ranging from 20.7 to 27.6 MPa (3,000 to 4,000 psi); reactive aggregates were identified as part of the concrete, especially (rhyolites and other silica-rich aggregates); cracking was attributed to swelling of the calcium-alkali-silica gel by-product of the alkali-aggregate reaction and subsequent cycles of freezing and thawing.

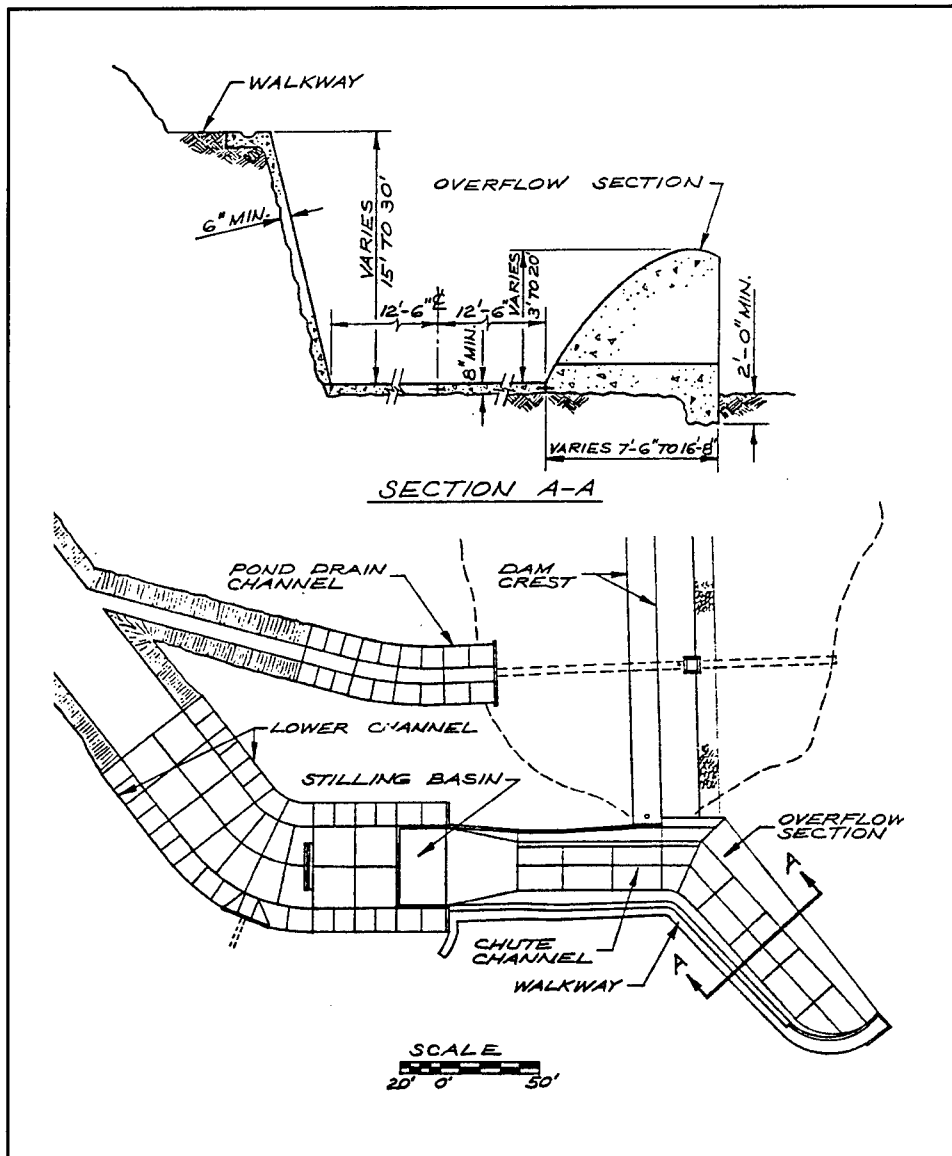
Figure 154. General plan for Vesuvius Dam and spillway (from Coghlan and Vanderpoel 1980) (multiply feet by 0.3048 to obtain metres; inches by 25.4 to obtain millimetres)

The concrete continued to deteriorate--cracking, spalling, raveling rock pockets, and efflorescence were evident. By 1977 there was concern about the structural integrity of the structure, so a decision was made to inspect all concrete areas in the spillway and pond drain channels and to make repairs where needed. This case history is a summary of a report by Coghlan and Vanderpoel (1980) on the investigation and repairs made at Vesuvius Dam spillway.

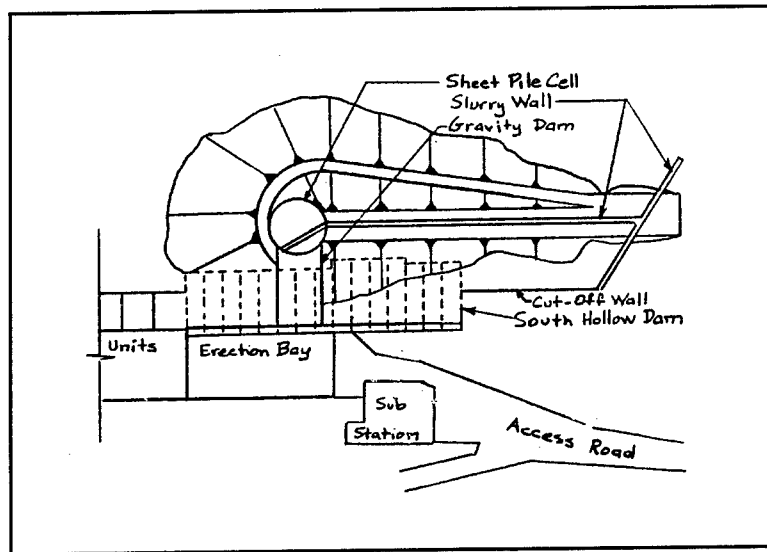
The original slab and buttress concrete was very lightly reinforced compared to today's standards. The inevitable seepage coupled with the use of nonair-entrained concrete used in construction and severe environmental conditions caused the concrete to deteriorate. In the early 1930s, concrete overlays were placed on parts of the upstream face to strengthen it, and support slabs and beams were placed under parts of the upstream face during repairs completed in 1934 and 1959. Asbestos transit panels were also installed on the downstream face of the dam. Although these repairs extended the life of the project, they did not rehabilitate the structure.

Two types of replacement dams were considered: a cellular sheet-pile dam or a sand-fill dam with an impervious cutoff. Also, a matter of consideration was how new and rehabilitated structures would be connected. A study indicated a sheet-pile cell would provide the easiest way to connect the two structures. The cell would also provide support for dewatering a small area or for placing tremie concrete. The study also indicated a sand-fill dam would be the most cost effective alternative, but that connecting it to the existing dam would be difficult. The final decision was a combination of the two alternatives (Figure 156).

The 103.6-m- (340-ft-) long sand-fill dam was placed underwater and consolidated by vibratory compaction. A positive cutoff slurry wall deeper than 18 m (60 ft) was constructed within the sand-fill dam. The dam was connected to a 17-m- (56-ft-) diam sheet-pile cell filled with concrete and sand. Perpendicular to the sheet-pile cell, a tremie-placed concrete dam connects the replacement dam to the existing face slab.

Figure 156. Plan for replacement of South dam at Wissota Hydroelectric Project (from LaMar, Ivarson, and Tonke-White 1991)

To strengthen the existing slab and buttress dam where it interfaces the new dam to support the concrete that would be placed against it, workers placed mass concrete between the buttresses behind the face slab, thus converting it to a gravity dam. This method was acceptable to the FERC because no significant volume of sand-fill removal was required at this location.

Two areas of concern for converting the slab and buttress portion to a gravity structure were good bond of the mass concrete to the foundation rock and control of temperature in the mass concrete during placement. The rough surface of the

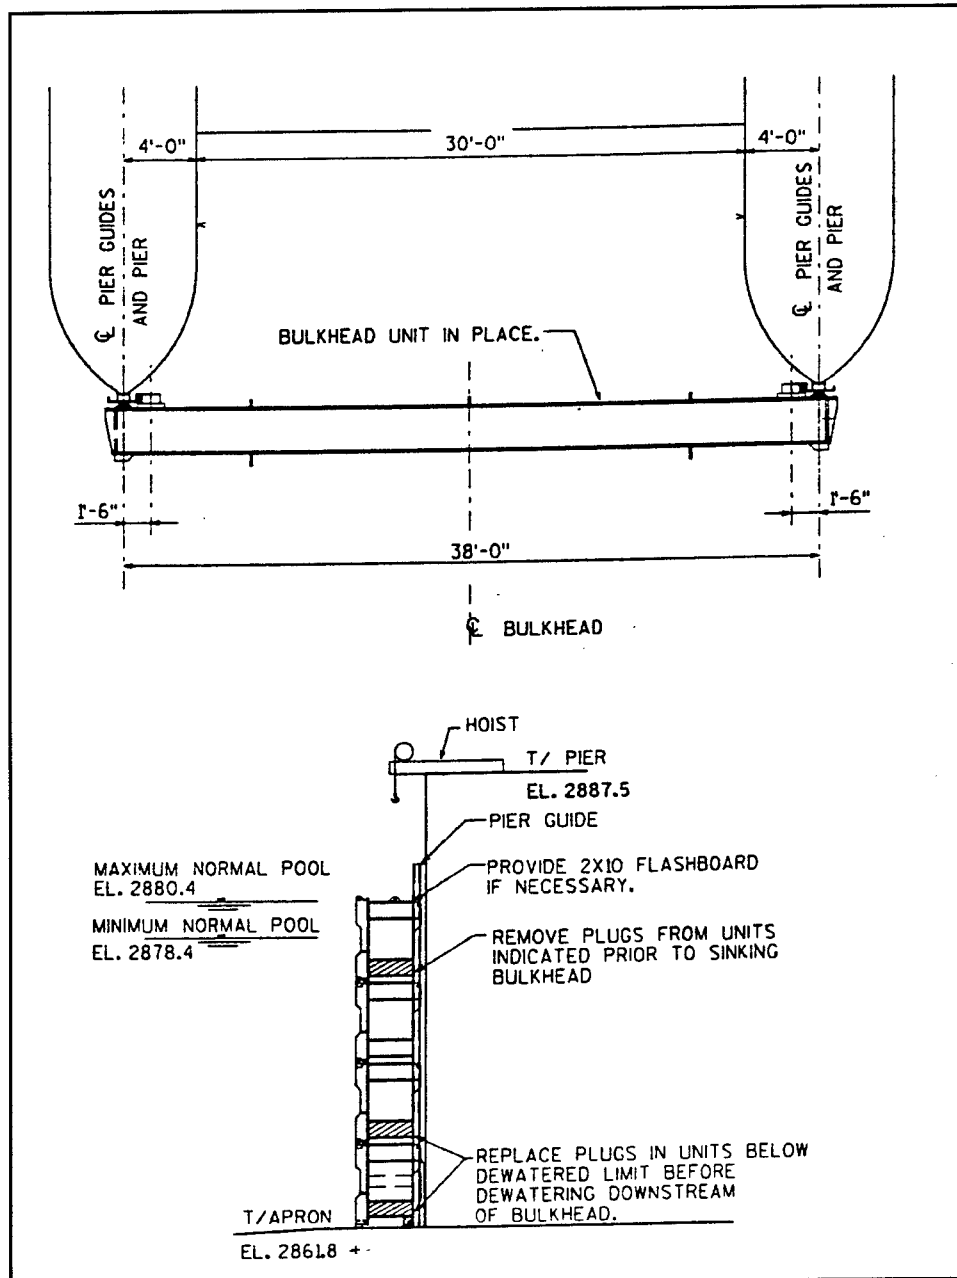
Figure 157. Cross section of design of floating bulkhead, Wissota Hydro Project

To repair head gates, stoplog slots, and trash racks, NSP had to develop a way to seal the entire fore bay of each unit or lower the reservoir to perform the repairs. Work in the head gate area would require a minimum of 4.6-m (15-ft) drawdown of Lake Wissota, which has a normal full-reservoir volume of 69,076,000 cu m (56,000 acre-ft), and the existing stop-log support trusses were too badly deteriorated to be considered. Rather than rent a barge and crane, NSP had an articulated floating bulkhead designed and fabricated for the project. The floating bulkhead was very similar in design to the one used at Snake River Dams. It was installed at the intakes of Lake Wissota hydroplant in 1987 (Figure 157) (Lux and Regner 1991).

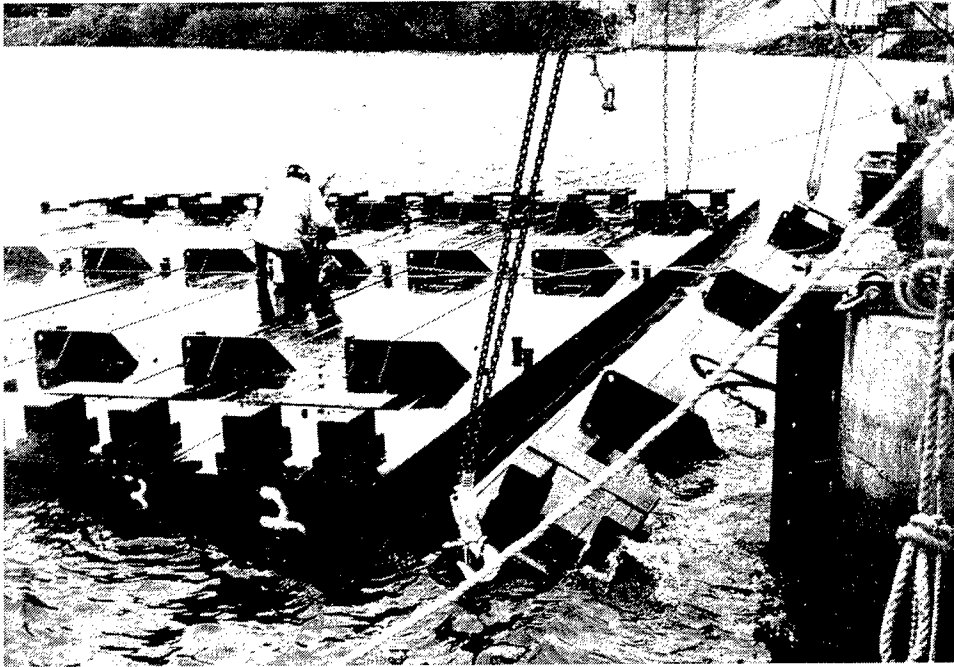
Figure 158. Caissons fill on floating bulkhead, causing bulkhead to sink, Wissota Hydro project

The floating bulkhead is constructed of nine caissons, each comprised of three compartments, which are used to float or sink the unit (Figure 158). The caissons are placed in the water and then linked together to form the bulkhead. The floating bulkhead fabricated for Wissota Hydro Project is 11 m (36 ft) square and 0.7 m (27 in.) thick when fully assembled (Figure 159). Because of its buoyancy, only 1,270 kg (2,800 lb) of the 62-Mg (68-ton) mass of the structure rests on the concrete below the headgate. Steel and wooden vertical guides installed on the pier noses are used to align the bulkhead. To sink the unit, the caissons are selectively filled. Water pressure from the lake seals the bulkhead. When repairs are completed, the water-filled compartments of the caissons are emptied, and the unit rises to the surface. The bulkhead has been installed in less than 2 hr and removed within 30 min. The bulkhead cost about \$130,000 (Lux and Regner 1991).

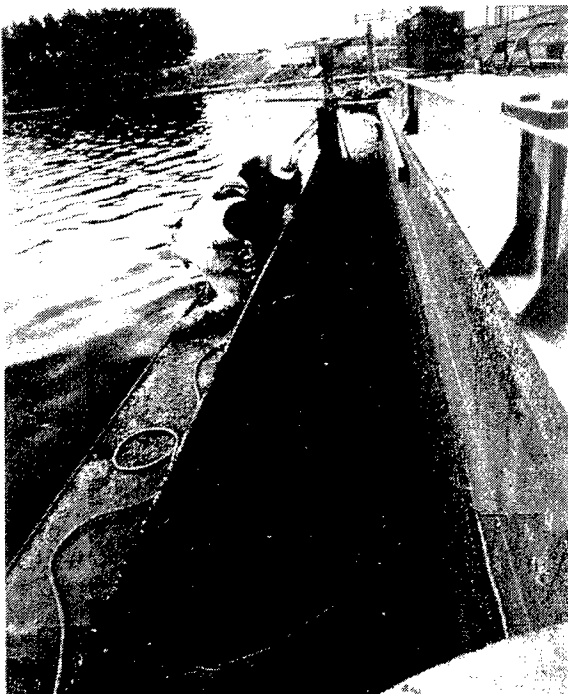
Figure 159. Floating bulkhead used to repair head gates, stop logs, and trash racks at Wissota Hydro Project
